# Denial-of-Service Vulnerability in Ethernet Communication Extension Unit (GC-ENET-COM) of GOC35 Series

**Release date:** March 31, 2023

**Mitsubishi Electric India Pvt. Ltd.**

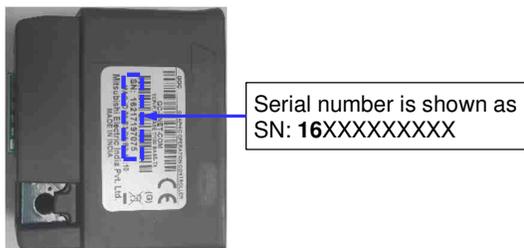
No.	Unit	Model Name	Serial Number
1	COM Extension unit	GC-ENET-COM	16XXXXXXXXX (First 2 digits of 11-digit serial number of unit are "16" and indicate product version)

Refer to serial number label on the left side of Extension unit GC-ENET-COM as shown below.

Firmware of Extension unit GC-ENET-COM which first 2 digits of 11-digit serial number of unit are "17" has been fixed.

Firmware update in Extension unit GC-ENET-COM is possible at factory only. Please contact your local Mitsubishi Electric India representative.
